IKT tested samples of tube liners from several hundred building sites. The results of the IKT tests show how different rehabilitation companies fared.

Analysis 2003/2004

IKT-LinerReport, January 2003 – June 2004

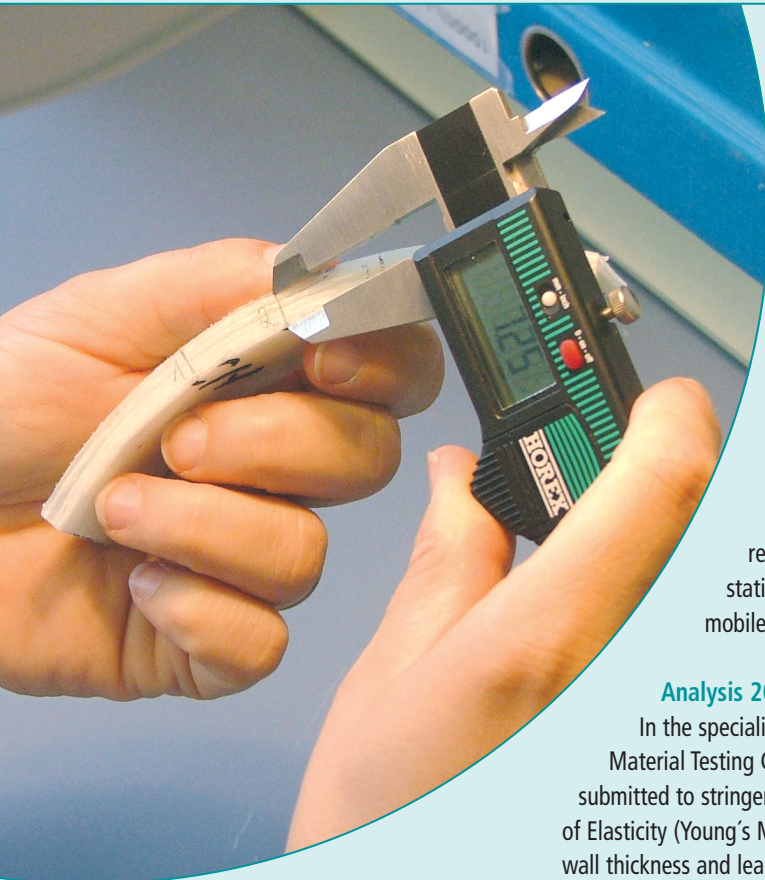
Wall thickness

quality control using the following test method. A precision caliper rule, measures the static carrying capacity of the wall thickness in 6 places. During the test, inner and outer foils as well as excess resin are not taken into account.

The third relevant criteria is the wall thickness. To determine this, an estimate in the static calculation is taken which later has to be reached when the liner is produced at the site. As the final liner form is only established after hardening, the wall diameter is tested on site as a

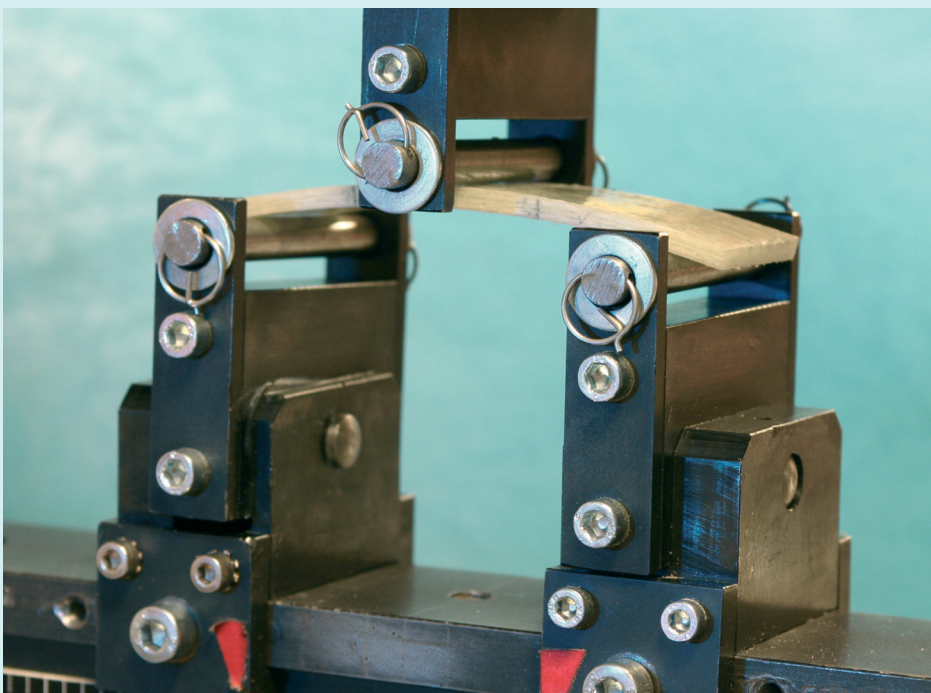
Another criteria to measure the liners load bearing capacity is its Flexural Strength. This is the moment when a liner cannot withstand a given pressure. If the Flexural Strength is too low a liner can break even before an acceptable deformation has been achieved. The testing method for this is the Three Point Bending Test whereby pressure is applied until the point of failure. This moment marks the start of breaking point (Flexural Strength).

Three point bending test

reference for this is the Modulus of Elasticity. The test method for site samples is the three point bending test which IKT uses as a short term test according to DIN EN ISO 178 and

DIN EN 13566-4. The sample passes the test if it reaches at minimum the reference value. The expected performance must relate to the manufacturers information based on trials and suitability tests, but also must meet the minimum specification of the client.

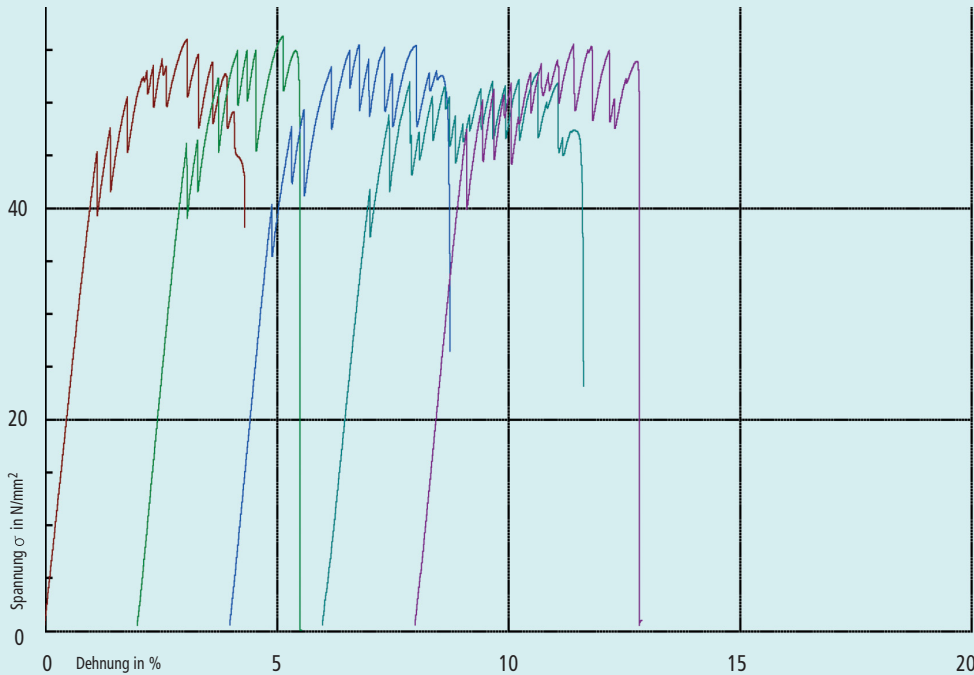
Felt liners stress/strain curve

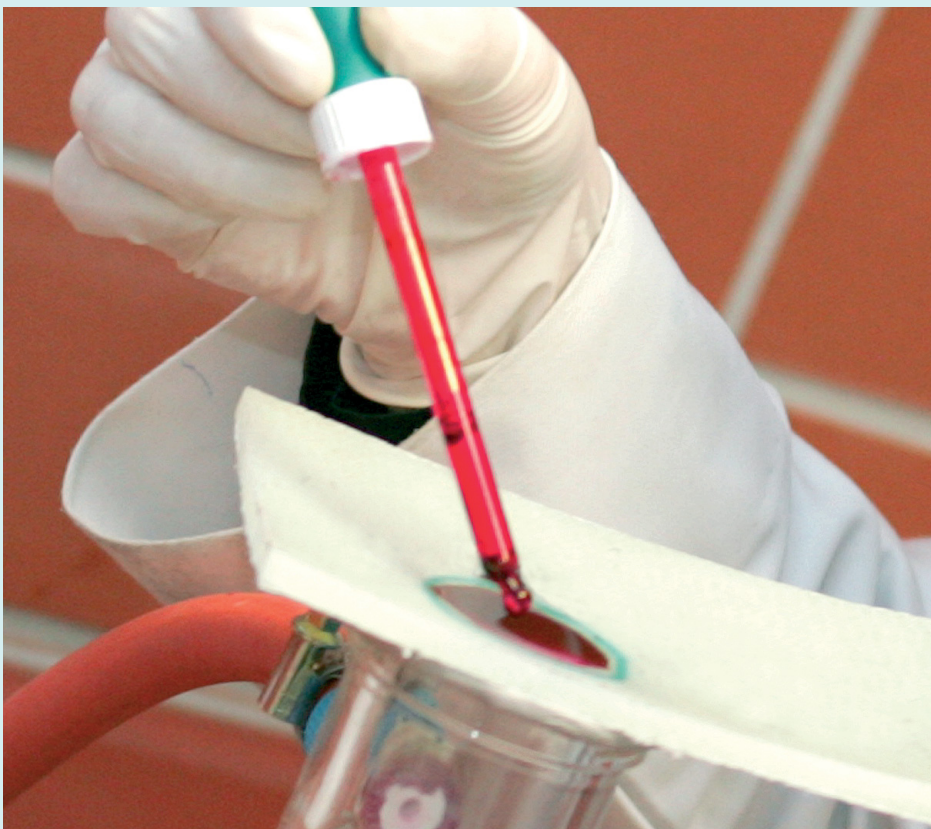
An important criteria is leak tightness, as liners are used to seal damaged waste water pipes. Test method: depending on the type of liner the outer foil is first removed from the sample and the inner foil is cut to a certain pattern. Then, red colored water is dripped onto the inside, whilst the outside is put under a negative pressure of 7,25 psi. If drops, foam or moisture appear on the outside, the liner is leaking.

Testing of leak tightness
