Tightness testing of a DN 1500 tube liner

IKT-LinerReport 2010

Tube liner water-tightness constantly improving

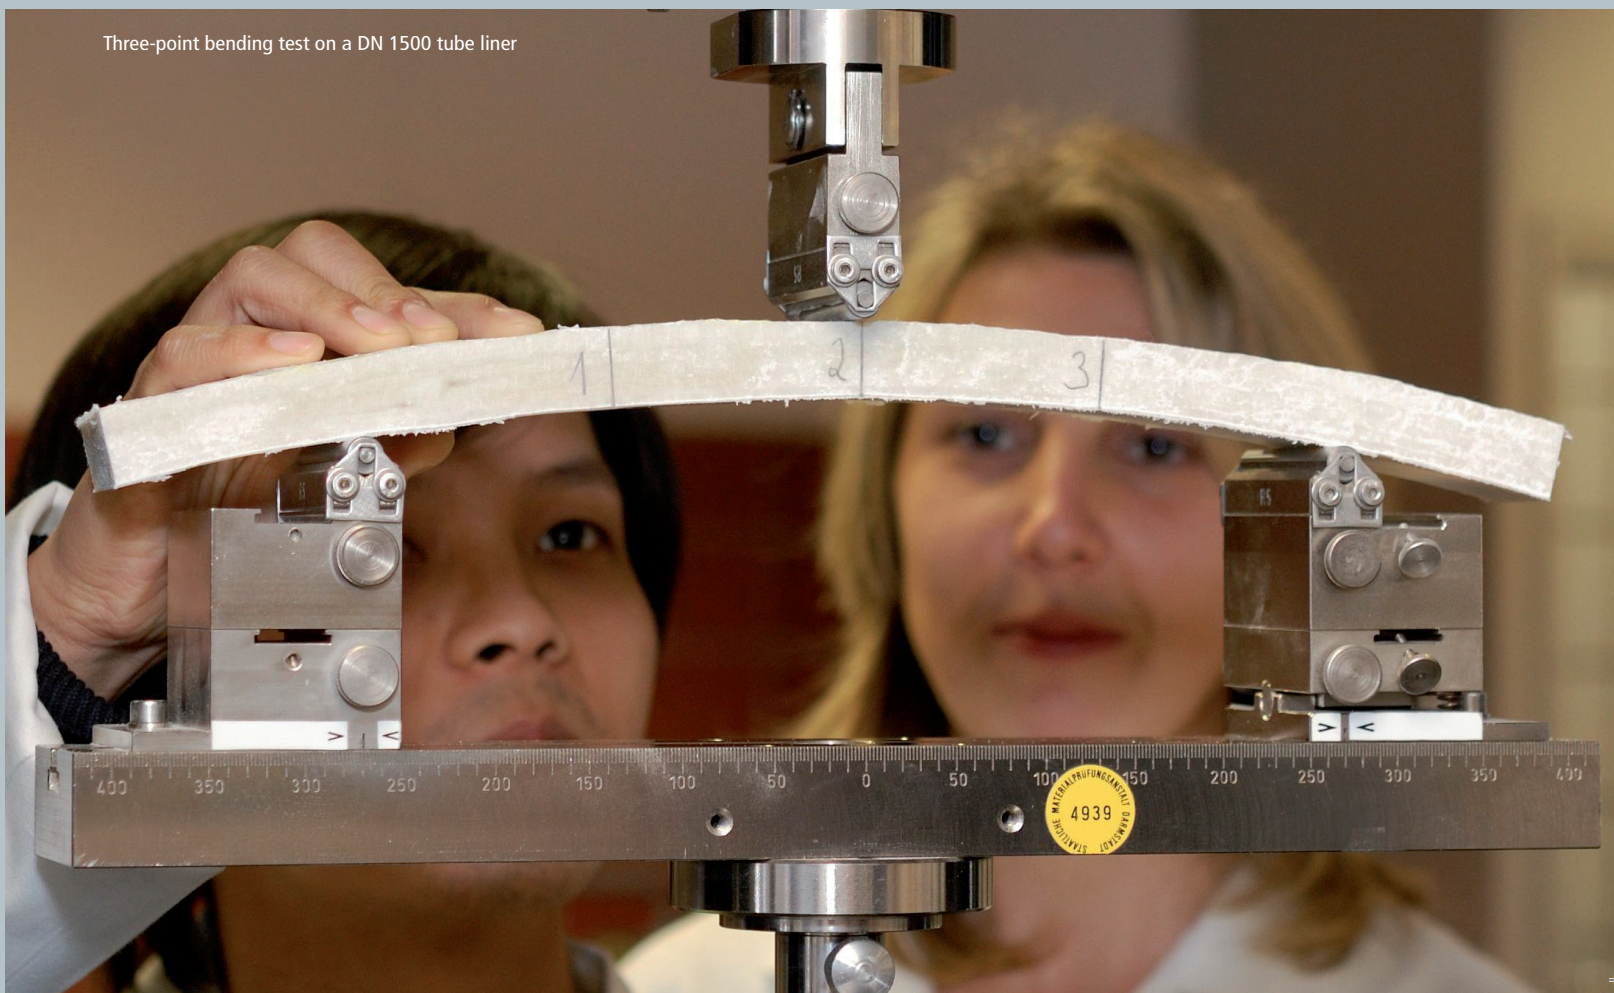
Three-point bending test on a DN 1500 tube liner

- (bending stress at rupture = short-term σ_{fb})
- This indicates the point at which the liner fails due to excessively high stress
 - If flexural strength is too low, the liner may rupture before the permissible deformation is reached
 - Test method: Increase of load up to failure in the three-point bending test; as per DIN EN ISO 178 and DIN EN 13 566, Part 4 (short-term flexural strength)
→Results: see Table 3

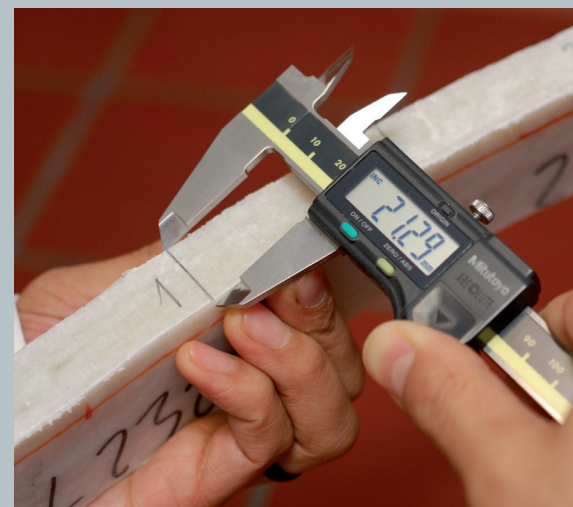
Liner wall-thickness is measured using a precision slide caliper gauge

- Minimum value is specified in the stress-analysis calculation
- Wall thickness and modulus of elasticity jointly determine the stiffness of the liners
- Excessively low wall thickness can endanger stability
- Test method: Mean combined thickness is measured in accordance with DIN EN 13 566, Part 4, using a precision slide gauge
→Results: see Table 4
